H-K Building 15
 Project Number: 0980193E
 Project: G. HEILEMAN BREWERY "E"
 Date Inspected: 03/28/89
 Inspector: MARK VOTH

ASBESTOS ASSESSMENT SURVEY

Building Number: 15
 Building Name: OLD KEG WASHING
 SEATTLE, WASHINGTON 98134
 Building Type: KEGGING
 Year Constructed: 1940

PROJECT NUMBER: 0980193E
HEILEMAN BREWING COMPANY
RAINIER BREWING COMPANY
BUILDING #15 OLD KEG WASHING

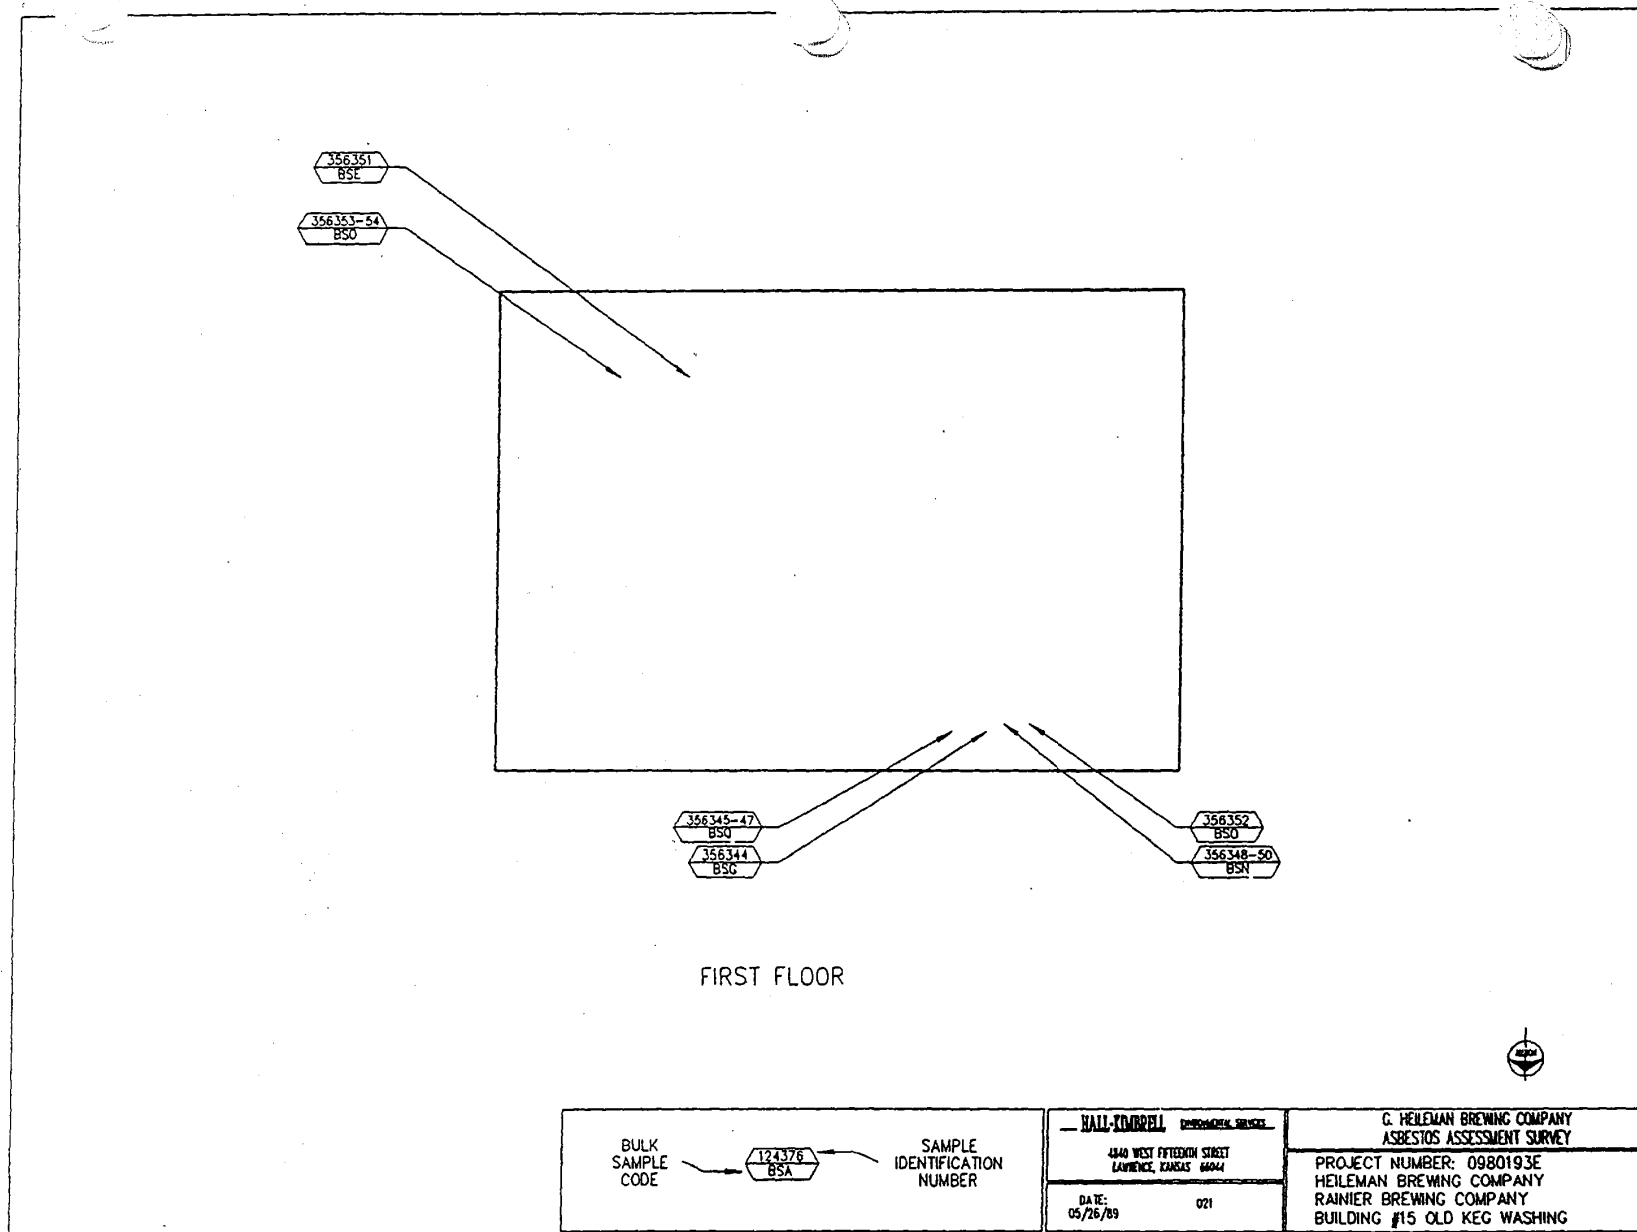
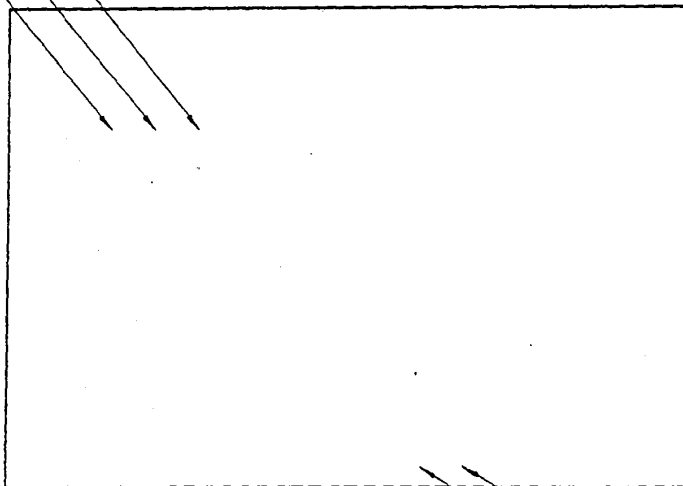
SECOND FLOOR

The materials are in fair condition with minor contact and water damage. The materials are approximately 1' to 10' from the floor. At a minimum, it is recommended that the materials be repaired and monitored. If removal is planned, gross removal procedures are recommended. This appears to be a low traffic area.
